REPORT OF SURVEY

Of that property described in Dkt. 3476, P. 87 of the Maricopa County, Arizona Records.

For K.O. LASSEN, D.V.M.
Box 295 Mesa, Arizona.

JOB 61-210
SCALE 1" = 30'

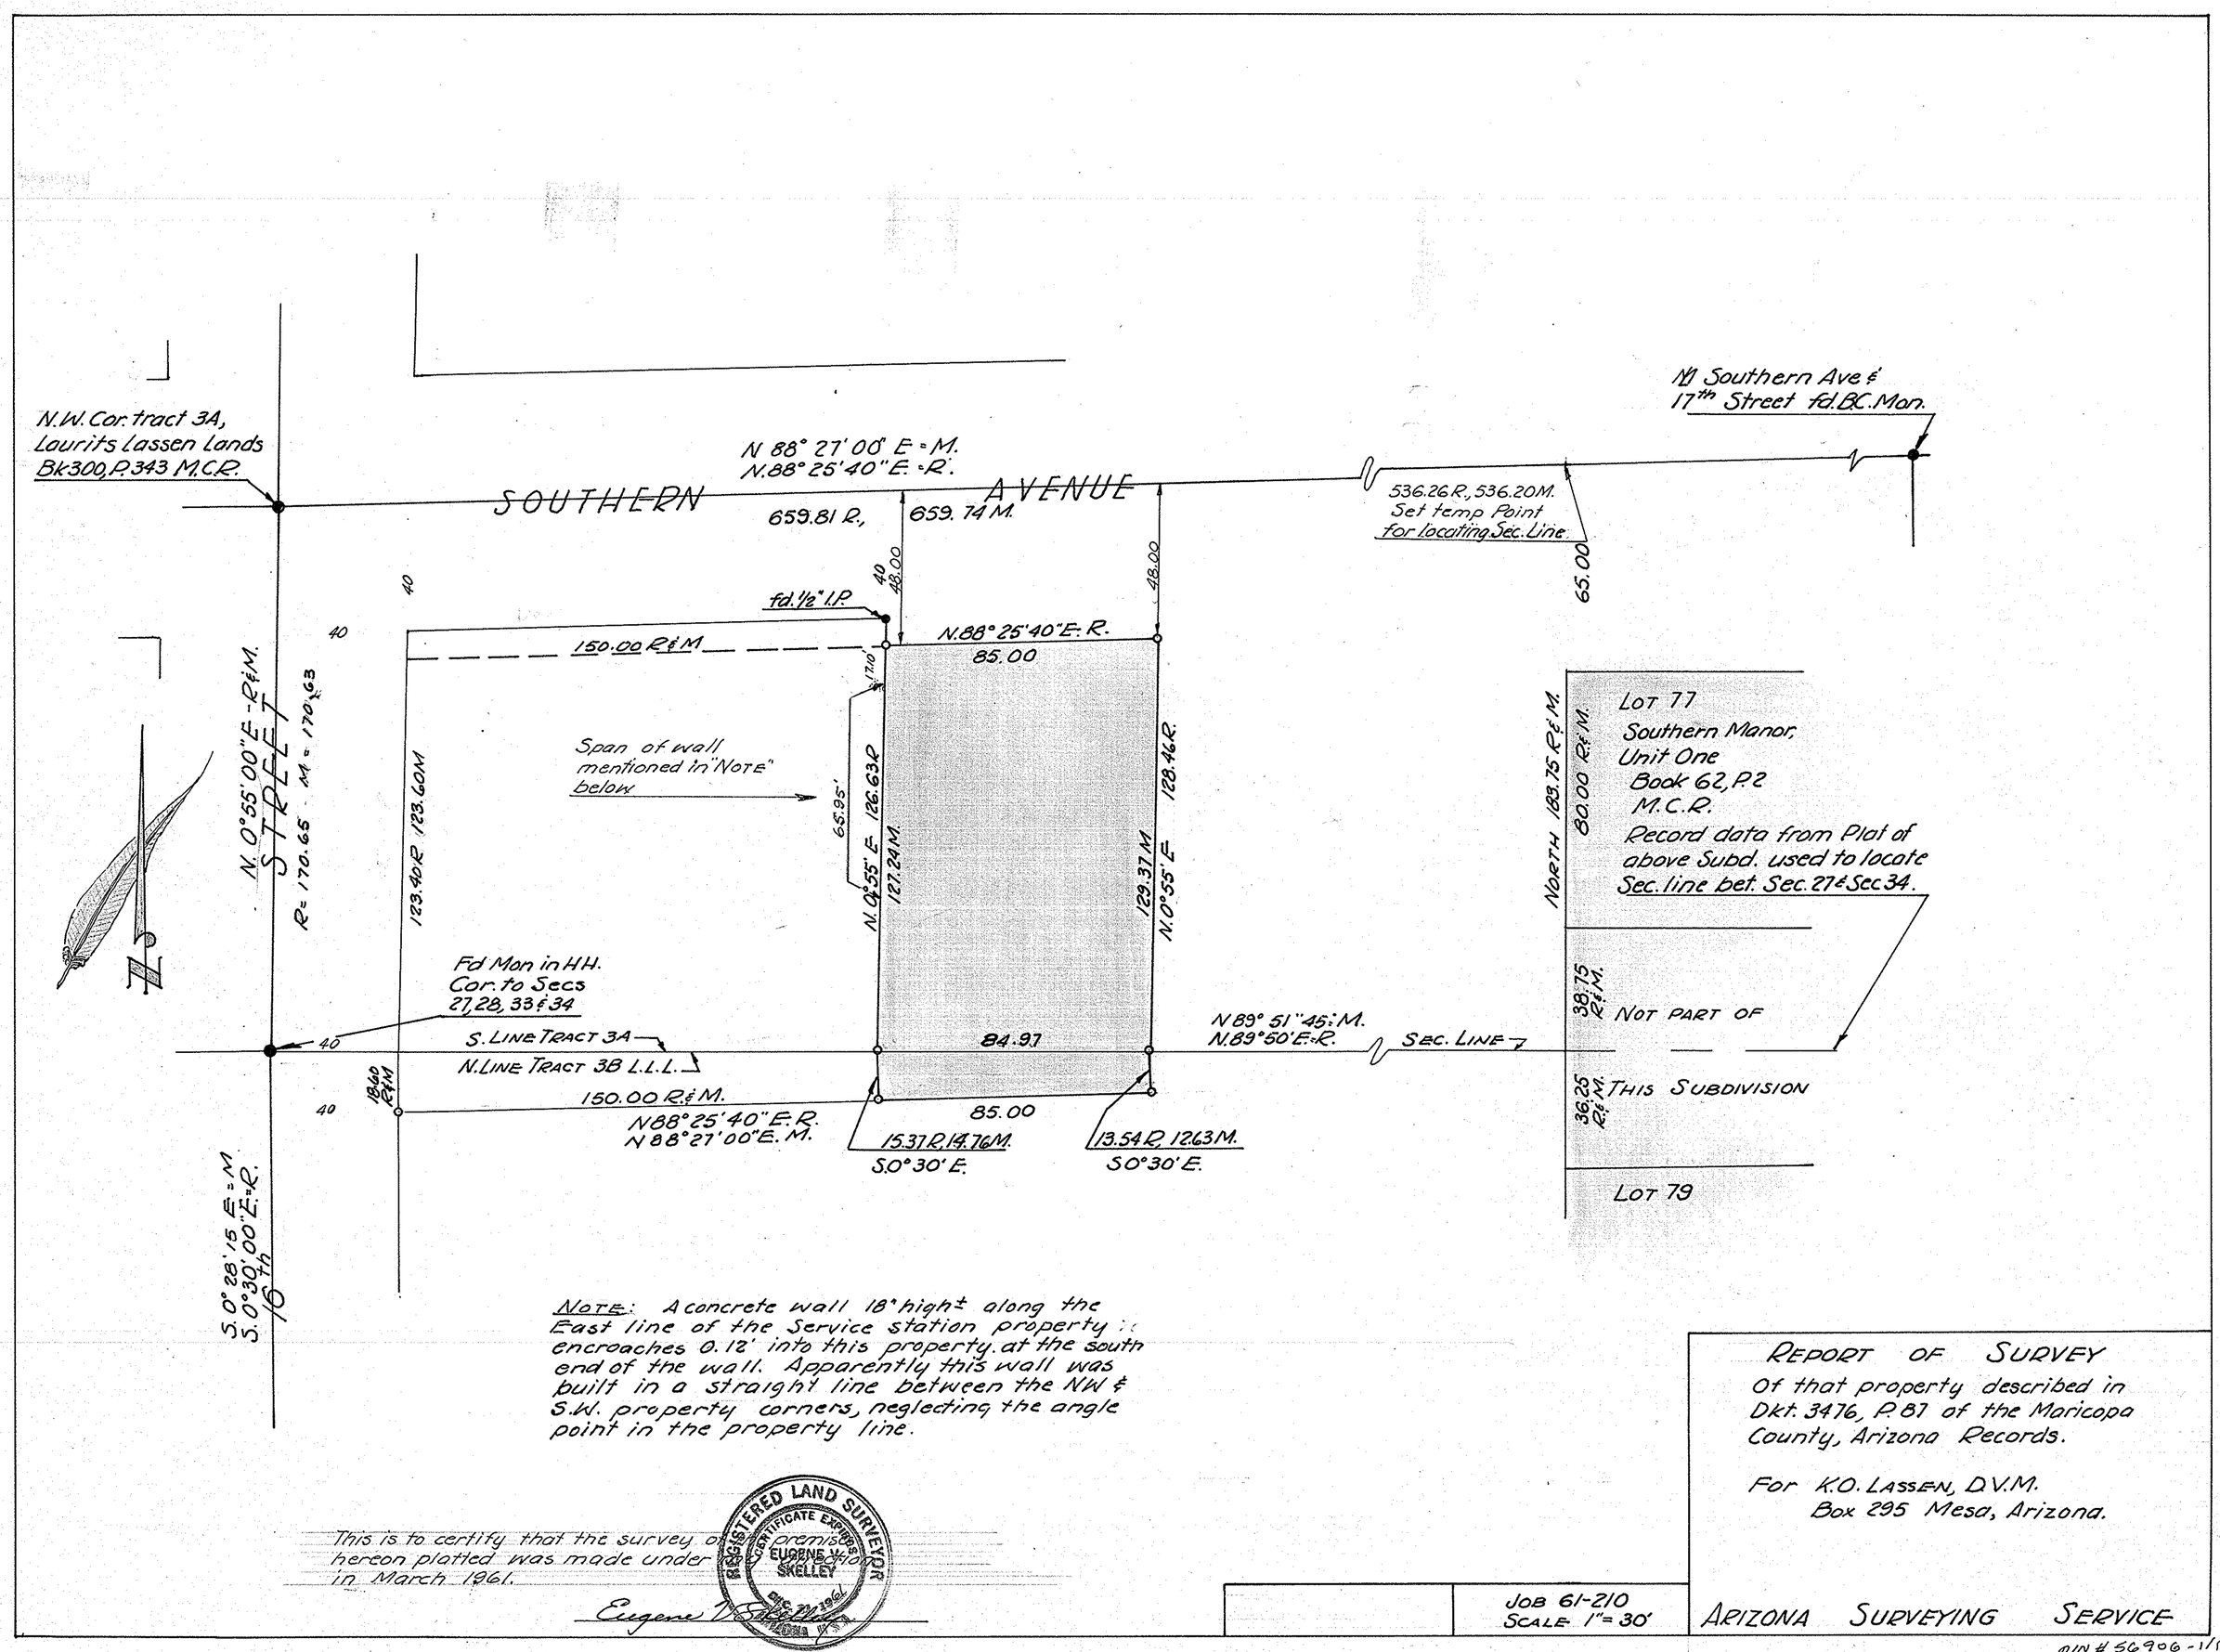
NOTE: A concrete wall 18" high± along the East line of the Service station property encroaches 0.12' into this property at the south end of the wall. Apparently this wall was built in a straight line between the NW & S.W. property corners, neglecting the angle point in the property line.
