JOB 61-210
SCALE 1" = 30'

REPORT OF SURVEY

Of that property described in Dkt. 3476, P. 87 of the Maricopa County, Arizona Records.

For K.O. LASSEN, D.V.M.
Box 295 Mesa, Arizona.

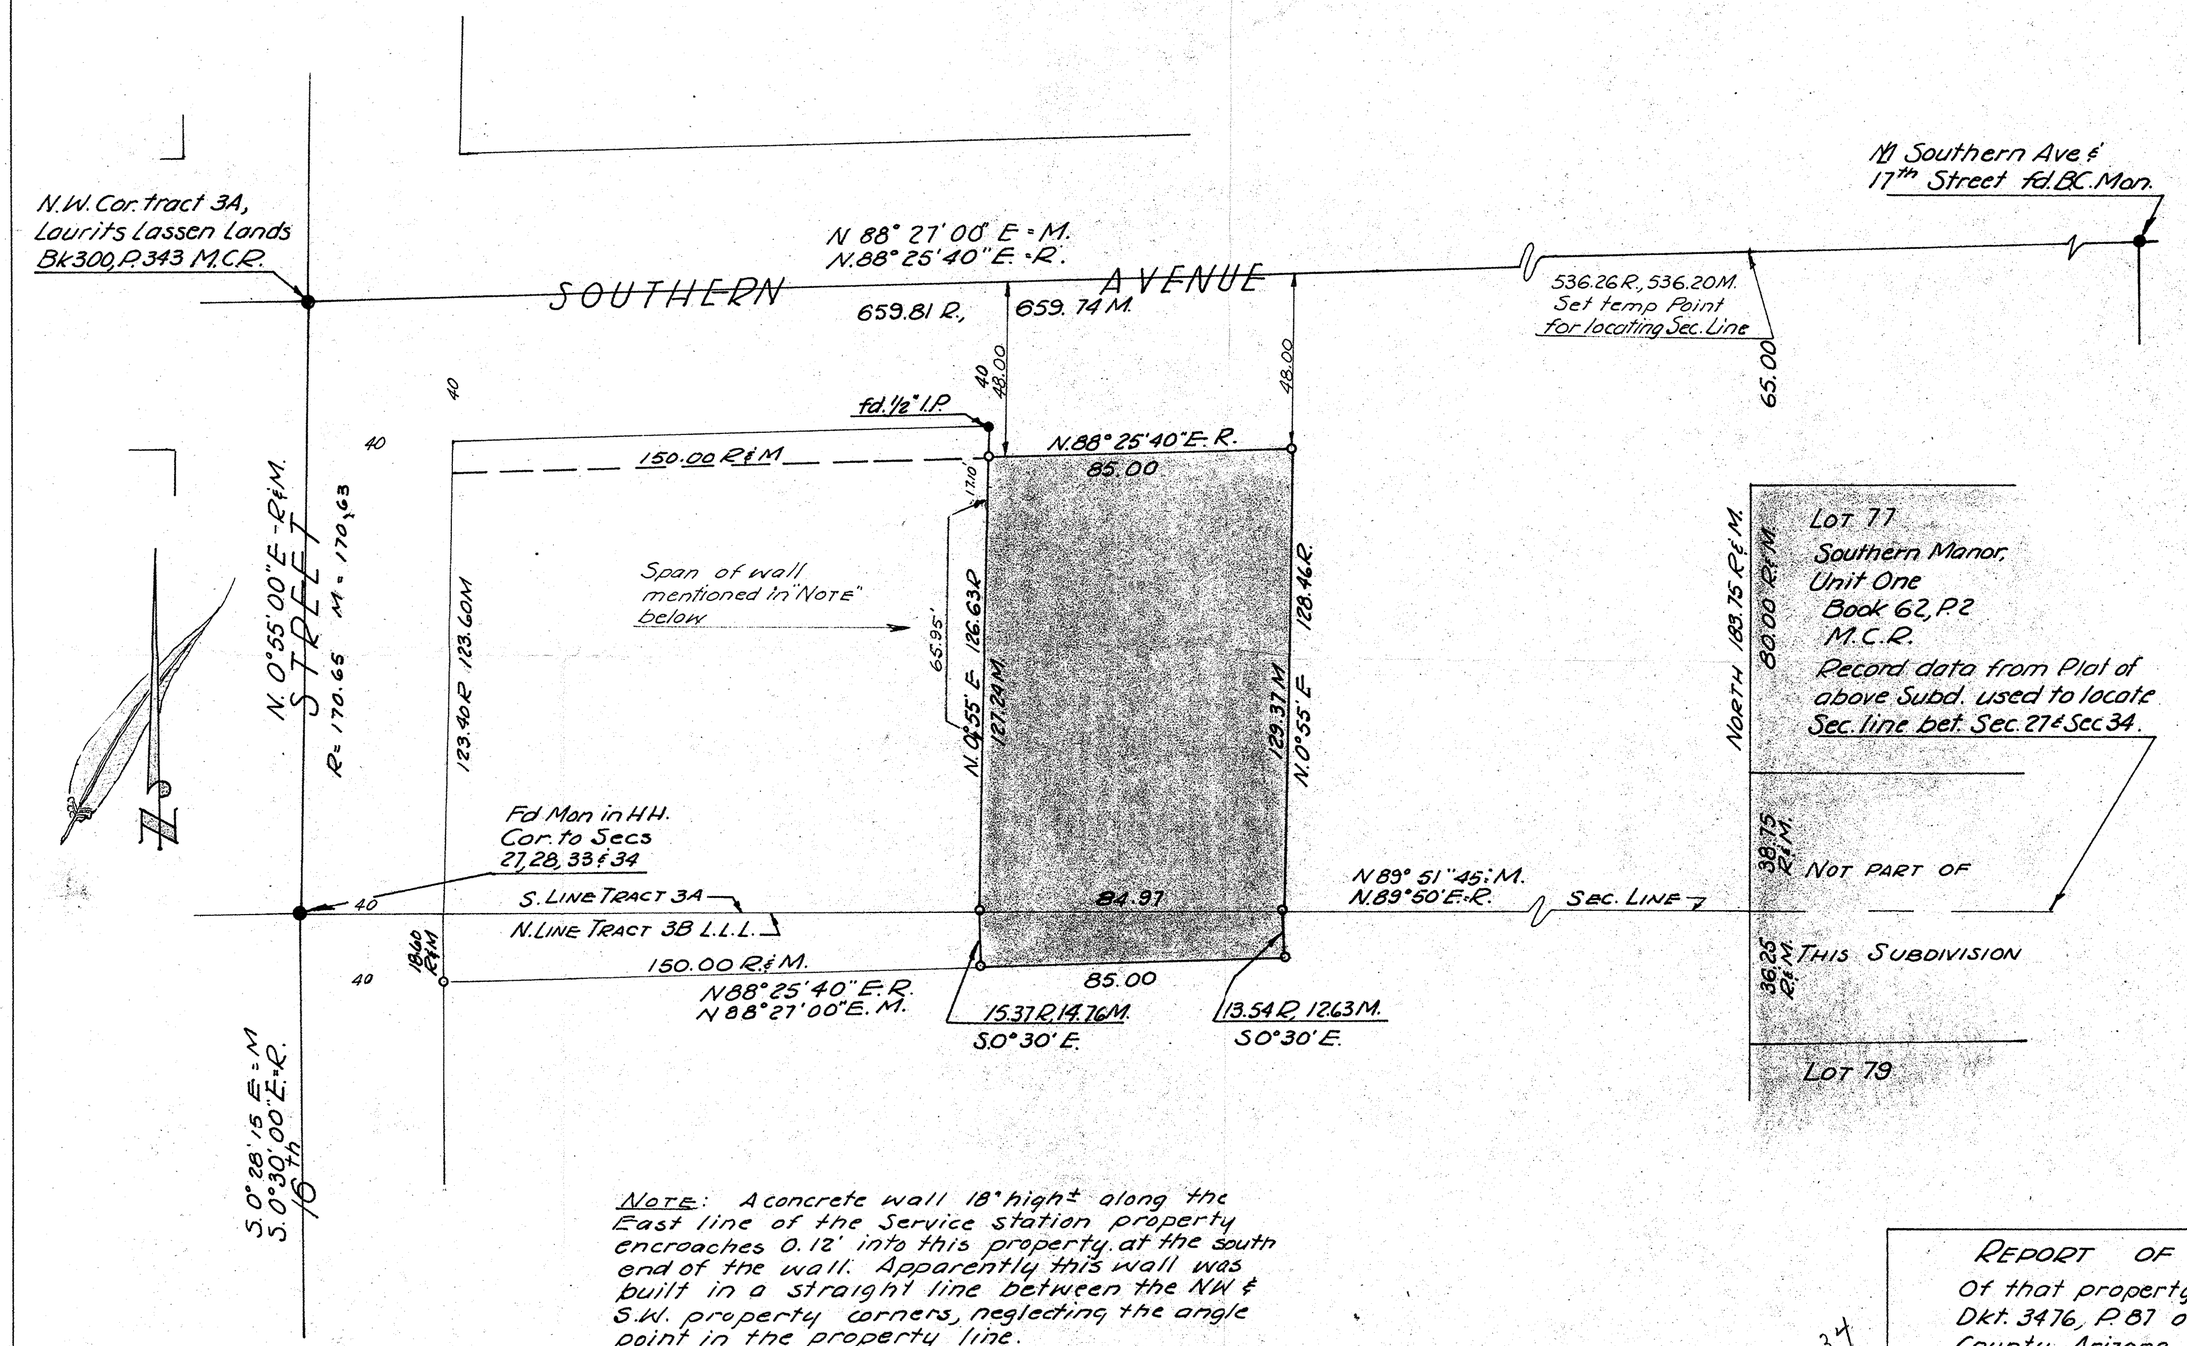
NOTE: A concrete wall 18" high± along the East line of the Service station property encroaches 0.12' into this property at the south end of the wall. Apparently this wall was built in a straight line between the NW & S.W. property corners, neglecting the angle point in the property line.
