REPORT OF SURVEY
Of that property described in Dkt. 3476, P. 87 of the Maricopa County, Arizona Records.

For K.O. LASSEN, D.V.M.
Box 295 Mesa, Arizona.

JOB 61-210
SCALE 1" = 30'

ARIZONA SURVEYING SERVICE

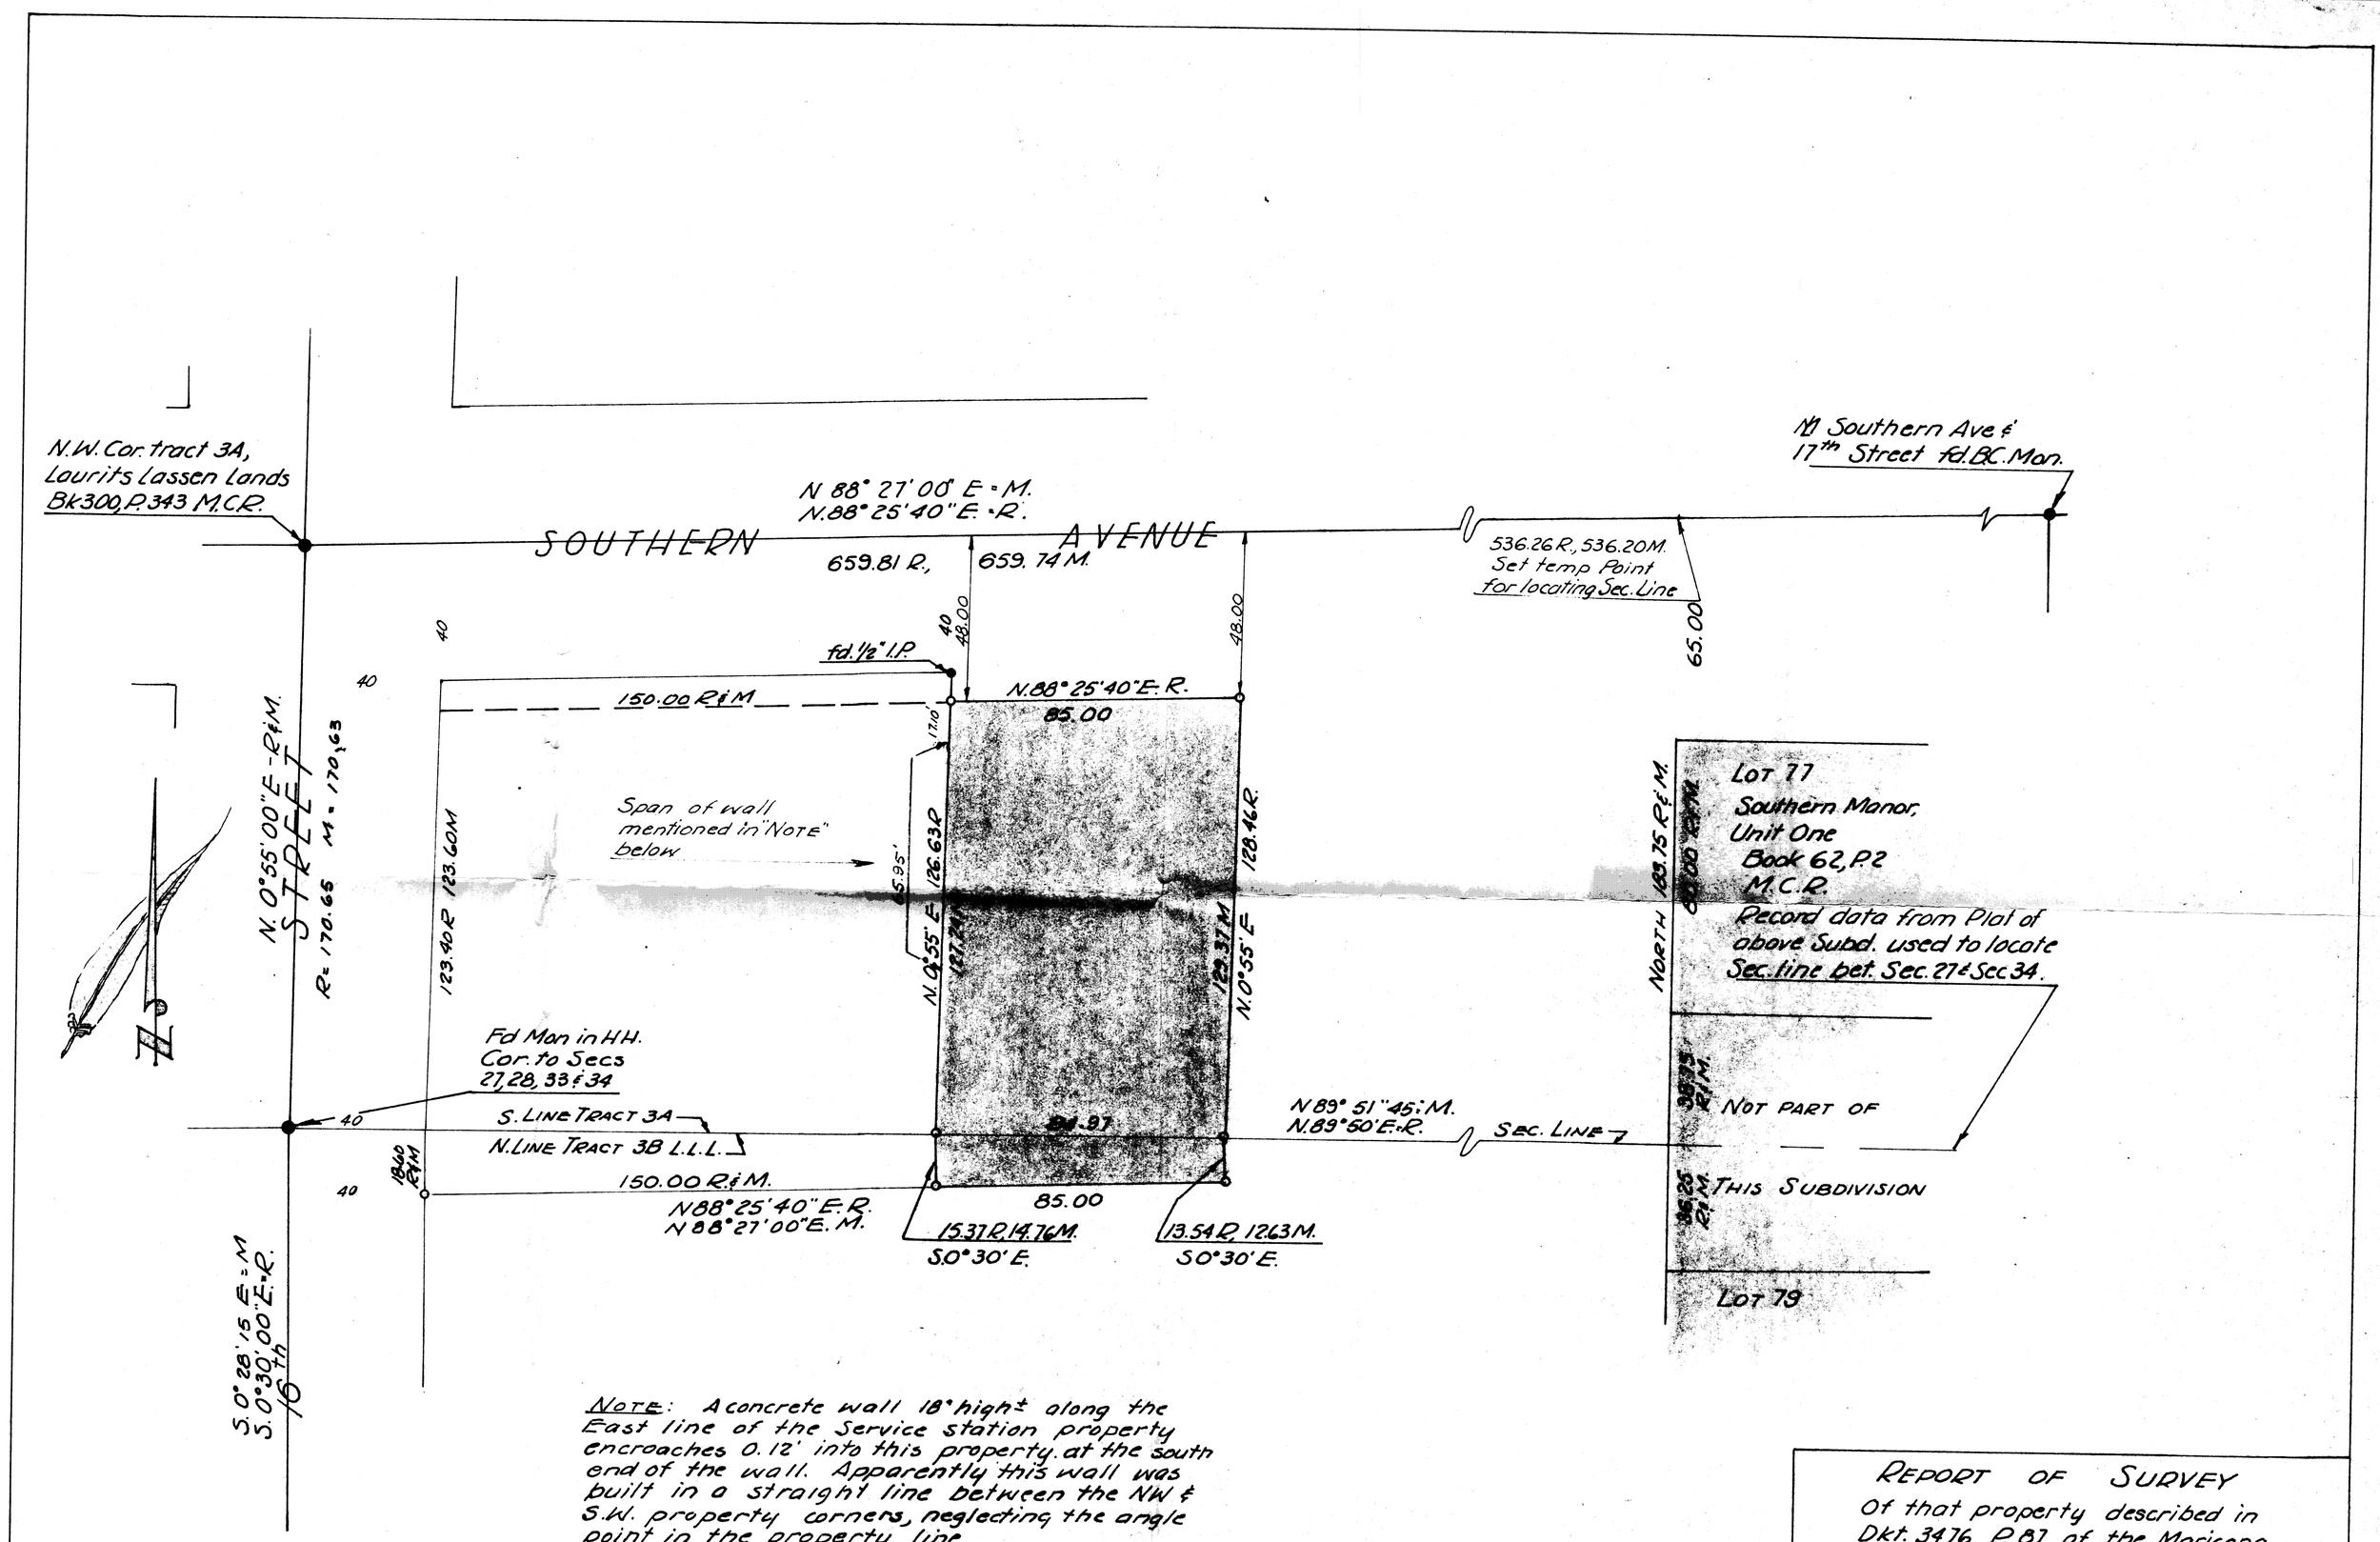
NOTE: A concrete wall 18" high± along the East line of the Service station property encroaches 0.12' into this property at the south end of the wall. Apparently this wall was built in a straight line between the NW & S.W. property corners, neglecting the angle point in the property line.
