JOB 61-222 SCALE: 1"=60'

For Mr & Mrs CHET NICHOLS

REPORT OF SURVEY
Of Lot 12, Block 8 of the Town of BUCKEYE as recorded in Book 4, p. 44 & 45 of the Maricopa Co. Arizona Records.

ARIZONA SURVEYING SERVICE

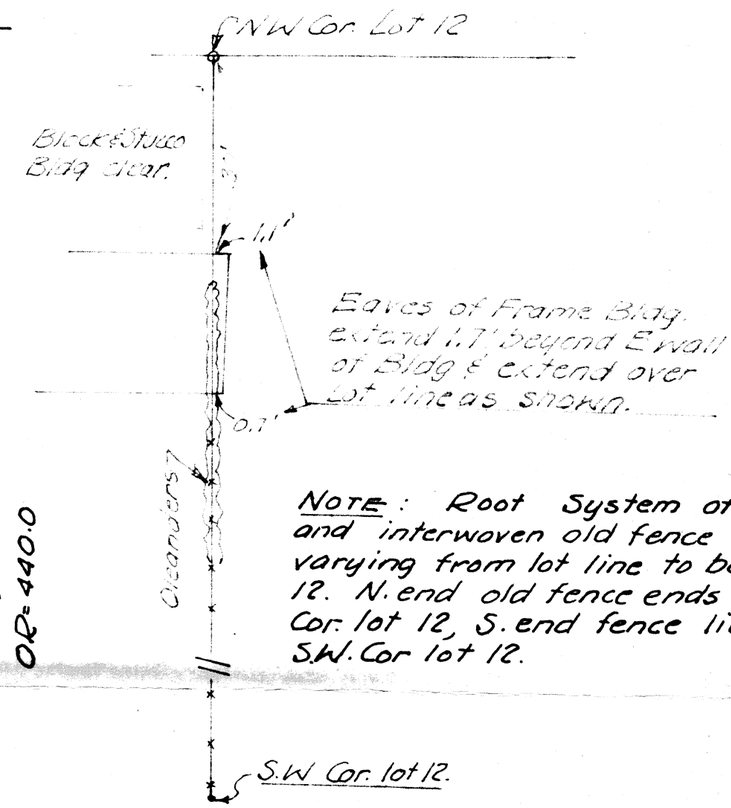
## ENCROACHMENT DIAGRAM.
Not to SCALE.

NOTE: Root System of Oleanders and interwoven old fence irregular – varying from lot line to being all on lot 12. N. end old fence ends 51' N. of S.W. Cor. lot 12, S. end fence lies 13' S. of S.W. Cor lot 12.
